Manhole Inspection Report

| MH#: | M-809-018 | Owner: | NA | Len. Surveyed: | 11.3 |

| Street: | Intersection of Bracken Parkway. an | Project: | Hobart, IN |

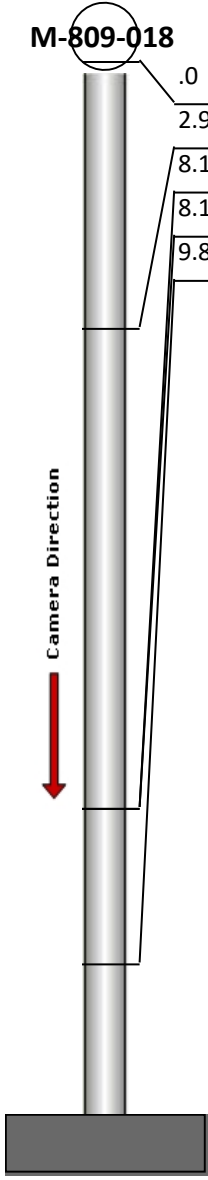
| | Position | Code | Observation | Video (sec) | Grade |
|--|---|---|---|---|---|
| | .0 | MGP | General Photo | 10 | NA |
| | 2.9 | MGP | General Photo | 30 | NA |
| | 8.1 | DAZ | Deposits Attached Other | 54 | M 2 |
| | 8.1 | IS | Infil Stain | 65 | NA |
| | 9.8 | MGO | General Observation | 80 | NA |
