Manhole Inspection Report

Date:	04/11/2018	Weather:		Coding:	RZMACP
MH#:	M-809-031	Owner:	NA	Len. Surveyed:	6.7
P.O.#:		Surveyor:	John Kuglmaier	Rim to Invert:	7.3
Customer:		Cert. #:	U-1215-07002349	Wall Material:	Concrete (reinforced)

Street:	Eider Ave. 471' Northwest of Bracke	Project:	Hobart, IN
City:	Hobart, IN	GPS Northing:	2908747.03
Location:		GPS Easting:	2908747.03
Drain Area:	Southwest	GPS Accuracy:	Sub-Meter
Cover Shape:	Circular	Evidence of Surcharge:	No
Cover Size:	22.5	Potential for Runoff:	None
Comments:

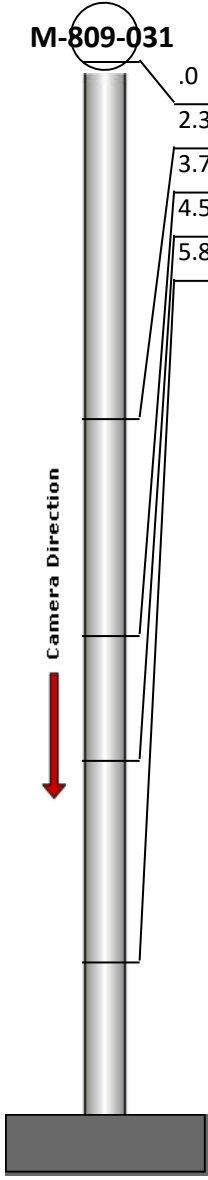
.0	MGP	General Photo	10	NA
	2.3	MGP	General Photo	28	NA
	3.7	DSF	Deposits Settled Fine	45	M 2
	4.5	IS	Infil Stain	58	NA
	5.8	MGO	General Observation	72	NA
