# Manhole Inspection Report

Date:	04/11/2018	Weather:		Coding:	RZMACP
MH#:	M-809-034	Owner:	NA	Len. Surveyed:	11.9
P.O.#:		Surveyor:	John Kuglmaier	Rim to Invert:	12.5
Customer:		Cert. #:	U-1215-07002349	Wall Material:	Concrete (reinforced)

Street:	Tanager St. 233' North of Kestrel St.	Project:	Hobart, IN
City:	Hobart, IN	GPS Northing:	0.0
Location:		GPS Easting:	0.0
Drain Area:	Southwest	GPS Accuracy:	Nearest Meter
Cover Shape:	Circular	Evidence of Surcharge:	No
Cover Size:	22.5	Potential for Runoff:	None
Comments:

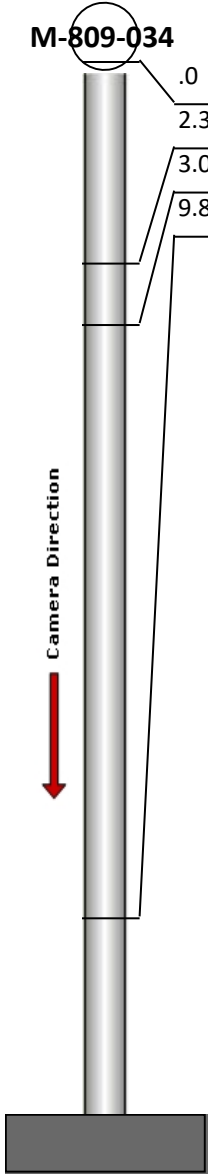
M-809-034				
	.0	MGP	General Photo	10	NA
	2.3	MGP	General Photo	29	NA
	3.0	IS	Infil Stain	44	NA
	9.8	MGO	General Observation	69	NA
