# Manhole Inspection Report

Date:	<b>04/11/2018</b>	Weather:		Coding:	<b>RZMACP</b>
MH#:	<b>M-809-037</b>	Owner:	<b>NA</b>	Len. Surveyed:	<b>12.0</b>
P.O.#:		Surveyor:	<b>John Kuglmaier</b>	Rim to Invert:	<b>12.9</b>
Customer:		Cert. #:	<b>U-1215-07002349</b>	Wall Material:	<b>Concrete (reinforced)</b>

Street:	<b>Merganser St. 537' East of Kestrel St.</b>	Project:	<b>Hobart, IN</b>
City:	<b>Hobart, IN</b>	GPS Northing:	<b>2907850.333</b>
Location:		GPS Easting:	<b>2907850.333</b>
Drain Area:	<b>Southwest</b>	GPS Accuracy:	<b>Sub-Meter</b>
Cover Shape:	<b>Circular</b>	Evidence of Surcharge:	<b>No</b>
Cover Size:	<b>22.5</b>	Potential for Runoff:	<b>None</b>
Comments:

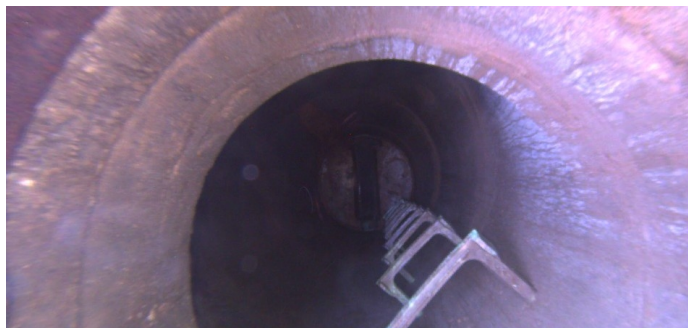
Code: **MGP**  
Description: **General Photo**

Distance (ft): **.0**  
Structural Grade: **0**  
O&M Grade: **0**  
Clock Start/From:  
Clock To:  
1st Value:  
2nd Value:  
Value Percent:  
Step: **NO**  
Remarks:

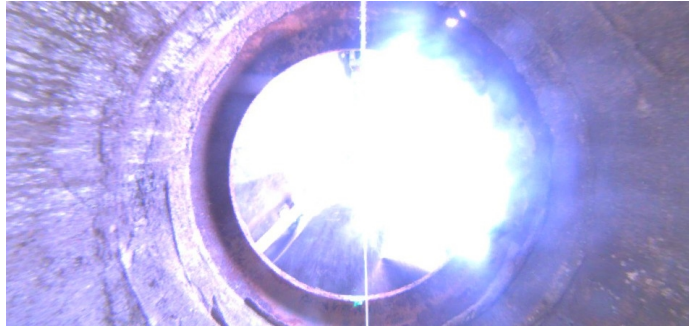
Code: **MGP**  
Description: **General Photo**

Distance (ft): **2.5**  
Structural Grade: **0**  
O&M Grade: **0**  
Clock Start/From:  
Clock To:  
1st Value:  
2nd Value:  
Value Percent:  
Step: **NO**  
Remarks:
