Manhole Inspection Report

Date:	04/11/2018	Weather:		Coding:	RZMACP
MH#:	M-809-040	Owner:	NA	Len. Surveyed:	7.6
P.O.#:		Surveyor:	John Kuglmaier	Rim to Invert:	8.1
Customer:		Cert. #:	U-1215-07002349	Wall Material:	Concrete (reinforced)

Street:	Kestrel St. 203' South of Merganser	Project:	Hobart, IN
City:	Hobart, IN	GPS Northing:	2907348.384
Location:		GPS Easting:	2907348.384
Drain Area:	Southwest	GPS Accuracy:	Sub-Meter
Cover Shape:	Circular	Evidence of Surcharge:	No
Cover Size:	22.5	Potential for Runoff:	None
Comments:

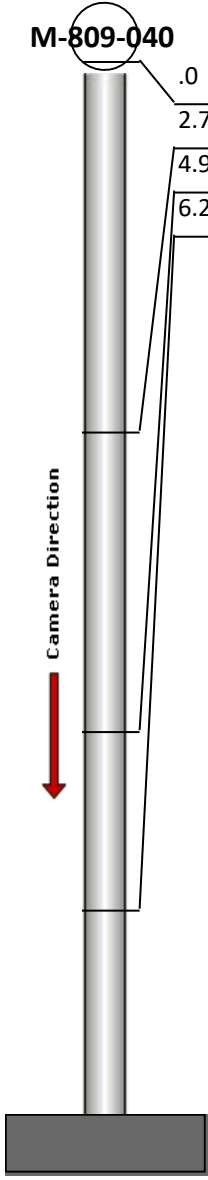
.0	MGP	General Photo	10	NA
	2.7	MGP	General Photo	29	NA
	4.9	DAZ	Deposits Attached Other	48	M 2
	6.2	MGO	General Observation	62	NA
