Manhole Inspection Report

Date:	04/11/2018	Weather:		Coding:	RZMACP
MH#:	M-809-042	Owner:	NA	Len. Surveyed:	7.9
P.O.#:		Surveyor:	John Kuglmaier	Rim to Invert:	8.2
Customer:		Cert. #:	U-1215-07002349	Wall Material:	Concrete (reinforced)

Street:	Kestrel St. 350' Southeast of Mergan	Project:	Hobart, IN
City:	Hobart, IN	GPS Northing:	2907482.926
Location:		GPS Easting:	2907482.926
Drain Area:	Southwest	GPS Accuracy:	Sub-Meter
Cover Shape:	Circular	Evidence of Surcharge:	No
Cover Size:	22.5	Potential for Runoff:	None
Comments:

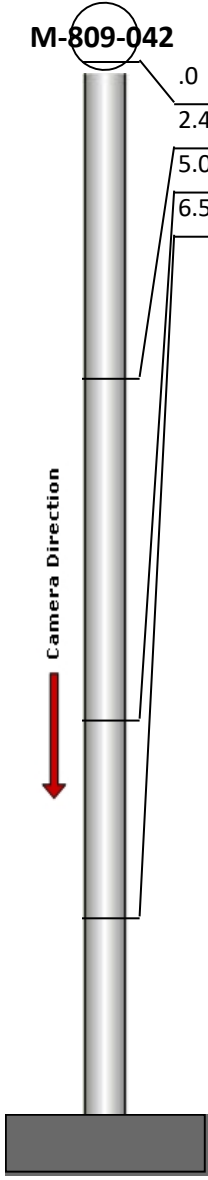
.0	MGP	General Photo	10	NA
	2.4	MGP	General Photo	29	NA
	5.0	DAZ	Deposits Attached Other	48	M 2
	6.5	MGO	General Observation	62	NA
