Manhole Inspection Report

Date:	04/11/2018	Weather:		Coding:	RZMACP
MH#:	M-809-044	Owner:	NA	Len. Surveyed:	7.1
P.O.#:		Surveyor:	John Kuglmaier	Rim to Invert:	7.8
Customer:		Cert. #:	U-1215-07002349	Wall Material:	Concrete (reinforced)

Street:	Kestrel St. 587' Southeast of Mergan	Project:	Hobart, IN
City:	Hobart, IN	GPS Northing:	2907804.551
Location:		GPS Easting:	2907804.551
Drain Area:	Southwest	GPS Accuracy:	Sub-Meter
Cover Shape:	Circular	Evidence of Surcharge:	No
Cover Size:	22.5	Potential for Runoff:	None
Comments:

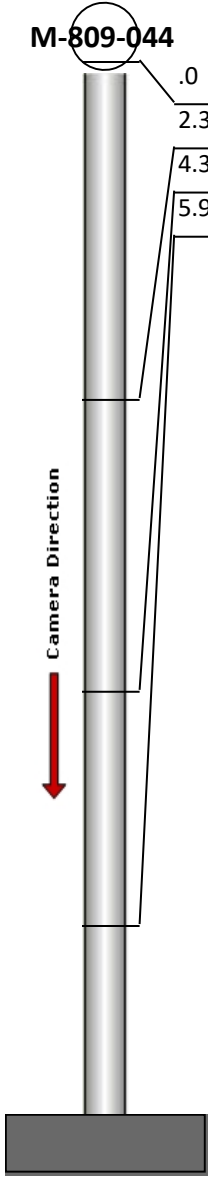
.0	MGP	General Photo	10	NA
	2.3	MGP	General Photo	29	NA
	4.3	DAZ	Deposits Attached Other	46	M 2
	5.9	MGO	General Observation	61	NA
