Manhole Inspection Report

Date:	04/12/2018	Weather:		Coding:	RZMACP
MH#:	M-809-055	Owner:	NA	Len. Surveyed:	5.1
P.O.#:		Surveyor:	John Kuglmaier	Rim to Invert:	5.7
Customer:		Cert. #:	U-1215-07002349	Wall Material:	Concrete (reinforced)

Street:	208' South of Bracken Parkway. Wes	Project:	Hobart, IN
City:	Hobart, IN	GPS Northing:	2909802.211
Location:		GPS Easting:	2909802.211
Drain Area:	Southwest	GPS Accuracy:	Sub-Meter
Cover Shape:	Circular	Evidence of Surcharge:	No
Cover Size:	22.5	Potential for Runoff:	None
Comments:

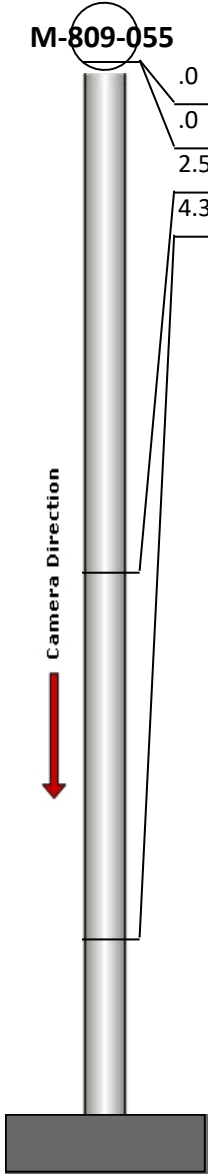
.0	MGP	General Photo	10	NA
	.0	RFJ	Roots Fine Joint	22	M 1
	2.5	MGP	General Photo	41	NA
	4.3	MGO	General Observation	58	NA
