Manhole Inspection Report

Date:	03/25/2018	Weather:		Coding:	RZMACP
MH#:	M-902-014	Owner:	NA	Len. Surveyed:	8.1
P.O.#:		Surveyor:	John Kuglmaier	Rim to Invert:	9.3
Customer:		Cert. #:	U-1215-07002349	Wall Material:	Concrete (reinforced)

Street:	194' East of Shelby St. South of 34th	Project:	Hobart, IN
City:	Hobart, IN	GPS Northing:	0.0
Location:		GPS Easting:	0.0
Drain Area:	Northeast	GPS Accuracy:	Nearest Meter
Cover Shape:	Circular	Evidence of Surcharge:	Yes
Cover Size:	23.0	Potential for Runoff:	None
Comments:

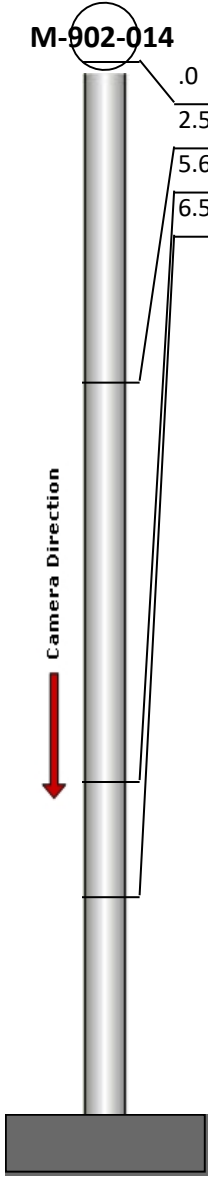
.0	MGP	General Photo	10	NA
	2.5	MGP	General Photo	29	NA
	5.6	MGO	General Observation	48	NA
	6.5	MGO	General Observation	62	NA
