Manhole Inspection Report

Date:	03/25/2018	Weather:		Coding:	RZMACP
MH#:	M-902-015	Owner:	NA	Len. Surveyed:	10.3
P.O.#:		Surveyor:	John Kuglmaier	Rim to Invert:	11.6
Customer:		Cert. #:	U-1215-07002349	Wall Material:	Concrete (reinforced)

Street:	194' East of Shelby St. South of 34th	Project:	Hobart, IN
City:	Hobart, IN	GPS Northing:	0.0
Location:		GPS Easting:	0.0
Drain Area:	Northeast	GPS Accuracy:	Nearest Meter
Cover Shape:	Circular	Evidence of Surcharge:	Yes
Cover Size:	23.0	Potential for Runoff:	None
Comments:

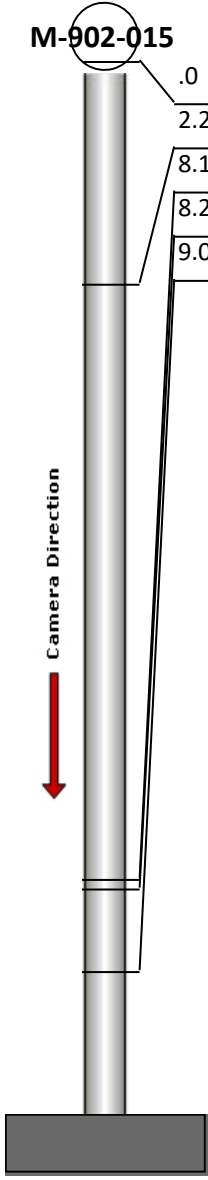
M-902-015				
	.0	MGP	General Photo	10	NA
	2.2	MGP	General Photo	28	NA
	8.1	DAZ	Deposits Attached Other	54	M 2
	8.2	IS	Infil Stain	66	NA
	9.0	MGO	General Observation	79	NA
