Manhole Inspection Report

Date:	09/19/2022	Weather:		Coding:	RZMACP
MH#:	M-902-019B	Owner:	NA	Len. Surveyed:	7.7
P.O.#:		Surveyor:	Jen Costello	Rim to Invert:	8.7
Customer:		Cert. #:	U-907-5518	Wall Material:	Concrete (cast in place)

Street:	North of 34th Ct. and 187' East of Sh	Project:	Hobart, IN
City:	Hobart, IN	GPS Northing:	2297741.339
Location:	Yard	GPS Easting:	2911047.042
Drain Area:	Northeast	GPS Accuracy:	Sub-Meter
Cover Shape:	Circular	Evidence of Surcharge:	No
Cover Size:	24.0	Potential for Runoff:	None
Comments:

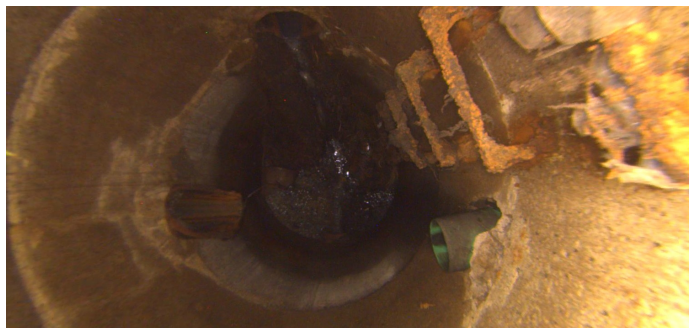
Code: **MGO**
Description: **General Observation**

Distance (ft): **.0**
Structural Grade: **0**
O&M Grade: **0**
Clock Start/From:
Clock To:
1st Value:
2nd Value:
Value Percent:
Step: **NO**
Remarks: **ACCESS MH**

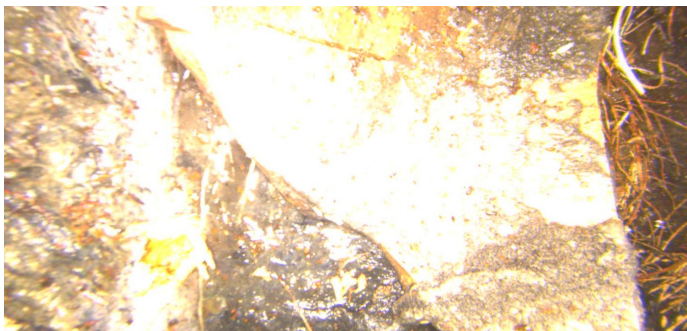
Code: **MGO**
Description: **General Observation**

Distance (ft): **7.7**
Structural Grade: **0**
O&M Grade: **0**
Clock Start/From:
Clock To:
1st Value:
2nd Value:
Value Percent:
Step: **NO**
Remarks: **END OF SURVEY**
