Manhole Inspection Report

Date:	03/24/2018	Weather:		Coding:	RZMACP
MH#:	M-902-026	Owner:	NA	Len. Surveyed:	7.1
P.O.#:		Surveyor:	John Kuglmaier	Rim to Invert:	8.0
Customer:		Cert. #:	U-1215-07002349	Wall Material:	Concrete (reinforced)

Street:	33rd Pl. 302' West of 33rd Ln.	Project:	Hobart, IN
City:	Hobart, IN	GPS Northing:	0.0
Location:		GPS Easting:	0.0
Drain Area:	Northeast	GPS Accuracy:	Nearest Meter
Cover Shape:	Circular	Evidence of Surcharge:	No
Cover Size:	23.0	Potential for Runoff:	None
Comments:

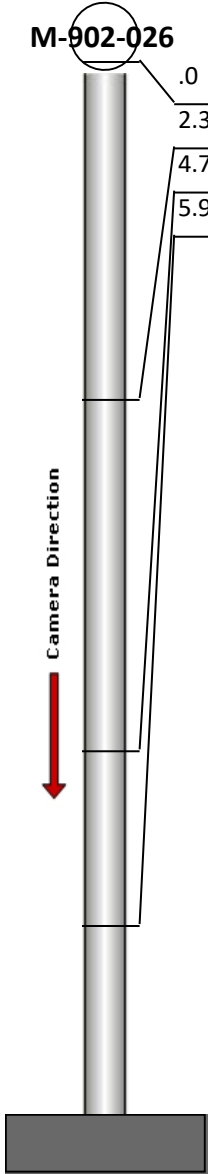
.0	MGP	General Photo	10	NA
	2.3	MGP	General Photo	28	NA
	4.7	DAZ	Deposits Attached Other	47	M 2
	5.9	MGO	General Observation	61	NA
