Manhole Inspection Report

Date:	03/25/2018	Weather:		Coding:	RZMACP
MH#:	M-902-027	Owner:	NA	Len. Surveyed:	13.0
P.O.#:		Surveyor:	John Kuglmaier	Rim to Invert:	16.5
Customer:		Cert. #:	U-1215-07002349	Wall Material:	Concrete (reinforced)

Street:	North of 34th Ave. West of Shelby S	Project:	Hobart, IN
City:	Hobart, IN	GPS Northing:	0.0
Location:		GPS Easting:	0.0
Drain Area:	Northeast	GPS Accuracy:	Nearest Meter
Cover Shape:	Circular	Evidence of Surcharge:	Yes
Cover Size:	23.0	Potential for Runoff:	None
Comments:

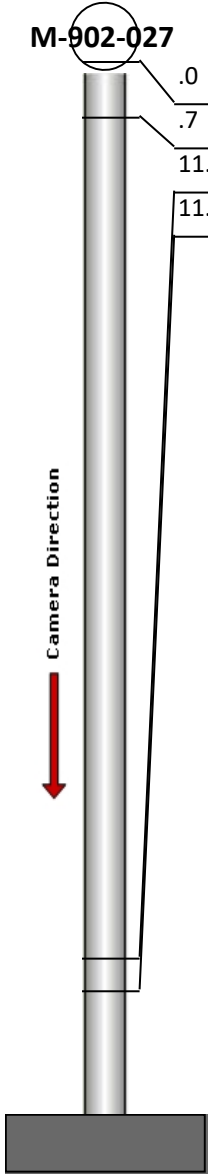
M-902-027				
	.0	MGP	General Photo	10	NA
	.7	MGP	General Photo	25	NA
	11.2	DAZ	Deposits Attached Other	60	M 2
	11.6	MGO	General Observation	72	NA
