Manhole Inspection Report

Date:	03/24/2018	Weather:		Coding:	RZMACP
MH#:	M-902-030	Owner:	NA	Len. Surveyed:	4.3
P.O.#:		Surveyor:	John Kuglmaier	Rim to Invert:	5.6
Customer:		Cert. #:	U-1215-07002349	Wall Material:	Concrete (reinforced)

Street:	Randolph St. North of 34th Ave.	Project:	Hobart, IN
City:	Hobart, IN	GPS Northing:	0.0
Location:		GPS Easting:	0.0
Drain Area:	Northeast	GPS Accuracy:	Nearest Meter
Cover Shape:	Circular	Evidence of Surcharge:	No
Cover Size:	23.0	Potential for Runoff:	None
Comments:

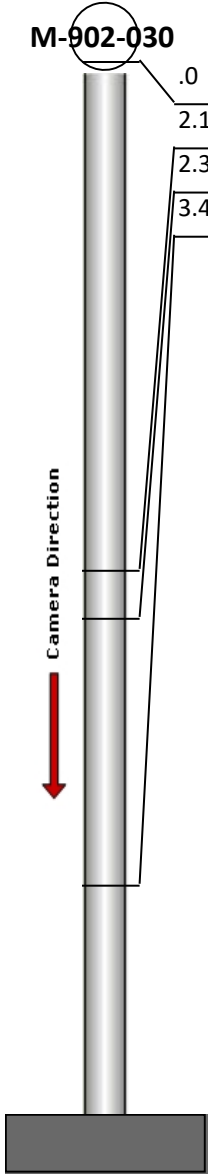
Position	Code	Observation	Video (sec)	Grade

.0	MGP	General Photo	10	NA
	2.1	MGP	General Photo	28	NA
	2.3	DAZ	Deposits Attached Other	42	M 2
	3.4	MGO	General Observation	56	NA
