Manhole Inspection Report

Date:	03/25/2018	Weather:		Coding:	RZMACP
MH#:	M-902-031	Owner:	NA	Len. Surveyed:	8.8
P.O.#:		Surveyor:	John Kuglmaier	Rim to Invert:	9.8
Customer:		Cert. #:	U-1215-07002349	Wall Material:	Concrete (reinforced)

Street:	256' East of Hwy 51. South of 34th L	Project:	Hobart, IN
City:	Hobart, IN	GPS Northing:	0.0
Location:		GPS Easting:	0.0
Drain Area:	Northeast	GPS Accuracy:	Nearest Meter
Cover Shape:	Circular	Evidence of Surcharge:	Yes
Cover Size:	23.0	Potential for Runoff:	None
Comments:

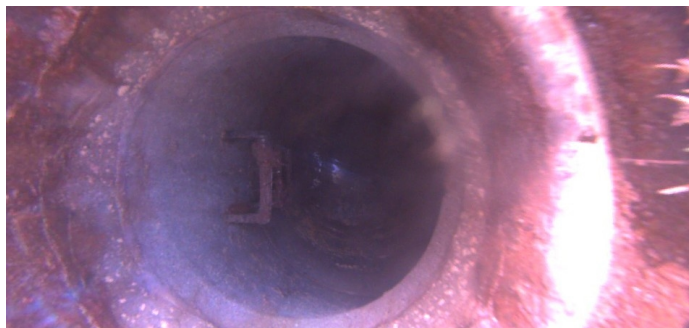
Code: **MGP**
Description: **General Photo**

Distance (ft): **.0**
Structural Grade: **0**
O&M Grade: **0**
Clock Start/From:
Clock To:
1st Value:
2nd Value:
Value Percent:
Step: **NO**
Remarks:

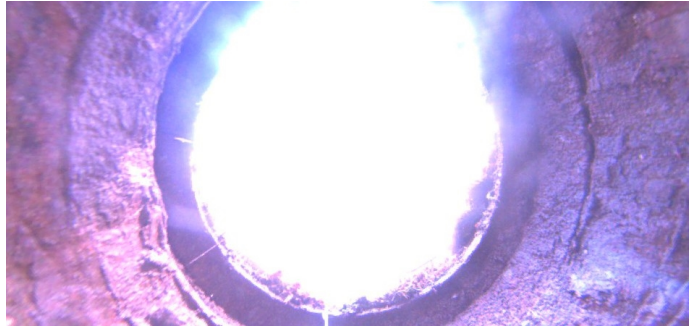
Code: **MGP**
Description: **General Photo**

Distance (ft): **2.1**
Structural Grade: **0**
O&M Grade: **0**
Clock Start/From:
Clock To:
1st Value:
2nd Value:
Value Percent:
Step: **NO**
Remarks:
