Manhole Inspection Report

| MH#: | M-902-042 | Owner: | NA | Len. Surveyed: | 6.9 |

| Street: | North of 34th Ln. 275' East of Rando | Project: | Hobart, IN |

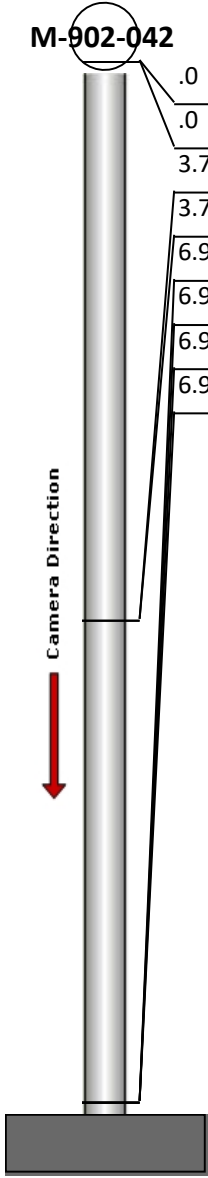
| | Position | Code | Observation | Video (sec) | Grade |
|--|---|---|---|---|---|
| | .0 | MGO | General Observation | 10 | NA |
| | .0 | SAV | Surface Aggregate Visible | 21 | S 3 |
| | 3.7 | MGO | General Observation | 42 | NA |
| | 3.7 | IW | Infil Weeper | 56 | M 2 |
| | 6.9 | DSGV | Deposits Settled Gravel | 73 | M 2 |
| | 6.9 | OBZ | Obstacle Other | 84 | M 2 |
| | 6.9 | SAV | Surface Aggregate Visible | 96 | S 3 |
| | 6.9 | MGO | General Observation | 107 | NA |
