Manhole Inspection Report

Date:	03/25/2018	Weather:		Coding:	RZMACP
MH#:	M-902-043	Owner:	NA	Len. Surveyed:	7.8
P.O.#:		Surveyor:	John Kuglmaier	Rim to Invert:	8.7
Customer:		Cert. #:	U-1215-07002349	Wall Material:	Concrete (reinforced)

Street:	North of 34th Ln. 101' East of Rando	Project:	Hobart, IN
City:	Hobart, IN	GPS Northing:	0.0
Location:		GPS Easting:	0.0
Drain Area:	Northeast	GPS Accuracy:	Nearest Meter
Cover Shape:	Circular	Evidence of Surcharge:	Yes
Cover Size:	23.0	Potential for Runoff:	None
Comments:

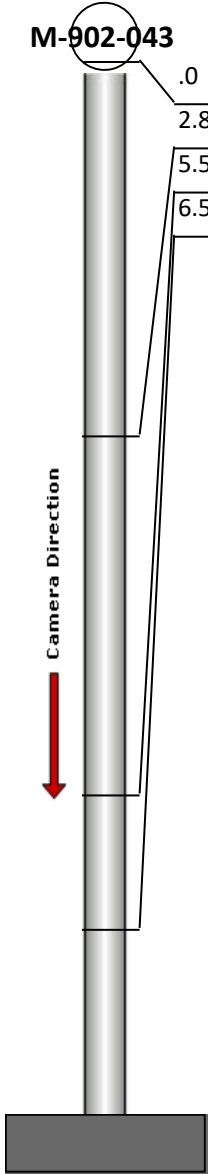
.0	MGP	General Photo	10	NA
	2.8	MGP	General Photo	29	NA
	5.5	MGO	General Observation	48	NA
	6.5	MGO	General Observation	62	NA
