Manhole Inspection Report

Date:	03/24/2018	Weather:		Coding:	RZMACP
MH#:	M-902-044	Owner:	NA	Len. Surveyed:	5.5
P.O.#:		Surveyor:	John Kuglmaier	Rim to Invert:	8.6
Customer:		Cert. #:	U-1215-07002349	Wall Material:	Concrete (reinforced)

Street:	Randolph St. South of 34th PL.	Project:	Hobart, IN
City:	Hobart, IN	GPS Northing:	0.0
Location:		GPS Easting:	0.0
Drain Area:	Northeast	GPS Accuracy:	Nearest Meter
Cover Shape:	Circular	Evidence of Surcharge:	Yes
Cover Size:	23.0	Potential for Runoff:	None
Comments:

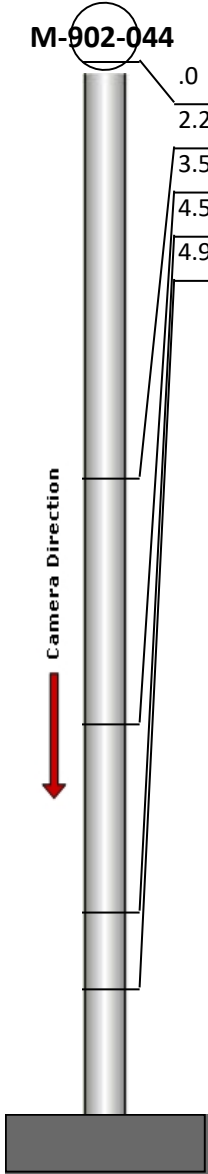
.0	MGP	General Photo	10	NA
	2.2	MGP	General Photo	28	NA
	3.5	DSF	Deposits Settled Fine	44	M 3
	4.5	RFC	Roots Fine Connection	58	M 1
	4.9	MGO	General Observation	70	NA
