Manhole Inspection Report

Date:	03/23/2018	Weather:		Coding:	RZMACP
MH#:	M-902-059	Owner:	NA	Len. Surveyed:	6.9
P.O.#:		Surveyor:	John Kuglmaier	Rim to Invert:	7.9
Customer:		Cert. #:	U-1215-07002349	Wall Material:	Concrete (reinforced)

Street:	Intersection of Rush Pl. and 36th Av	Project:	Hobart, IN
City:	Hobart, IN	GPS Northing:	0.0
Location:		GPS Easting:	0.0
Drain Area:	Northeast	GPS Accuracy:	Nearest Meter
Cover Shape:	Circular	Evidence of Surcharge:	No
Cover Size:	23.0	Potential for Runoff:	None
Comments:

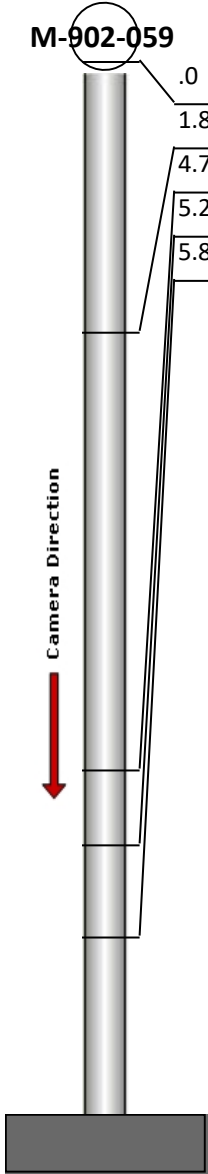
.0	MGP	General Photo	10	NA
	1.8	MGP	General Photo	27	NA
	4.7	DSF	Deposits Settled Fine	47	M 2
	5.2	OBZ	Obstacle Other	59	M 2
	5.8	MGO	General Observation	72	NA
