Manhole Inspection Report

Date:	03/21/2018	Weather:		Coding:	RZMACP
MH#:	M-902-065	Owner:	NA	Len. Surveyed:	5.8
P.O.#:		Surveyor:	John Kuglmaier	Rim to Invert:	7.0
Customer:		Cert. #:	U-1215-07002349	Wall Material:	Concrete (reinforced)

Street:	234' North of Hwy 6. West of Union	Project:	Hobart, IN
City:	Hobart, IN	GPS Northing:	0.0
Location:		GPS Easting:	0.0
Drain Area:	Northeast	GPS Accuracy:	Nearest Meter
Cover Shape:	Circular	Evidence of Surcharge:	No
Cover Size:	23.0	Potential for Runoff:	None
Comments:

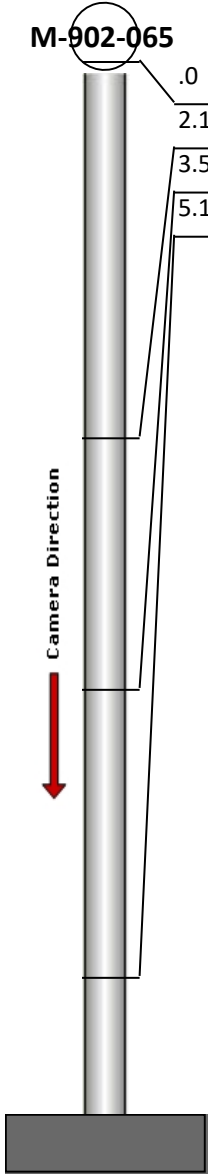
.0	MGP	General Photo	10	NA
	2.1	MGP	General Photo	28	NA
	3.5	DAZ	Deposits Attached Other	44	M 2
	5.1	MGO	General Observation	59	NA
