Manhole Inspection Report

Date:	03/20/2018	Weather:		Coding:	RZMACP
MH#:	M-903-007	Owner:	NA	Len. Surveyed:	6.8
P.O.#:		Surveyor:	John Kuglmaier	Rim to Invert:	8.0
Customer:		Cert. #:	U-1215-07002349	Wall Material:	Concrete (reinforced)

Street:	Intersection of Spencer Pl. and 38th	Project:	Hobart, IN
City:	Hobart, IN	GPS Northing:	2911582.506
Location:		GPS Easting:	2911582.506
Drain Area:	Northeast	GPS Accuracy:	Sub-Meter
Cover Shape:	Circular	Evidence of Surcharge:	No
Cover Size:	23.0	Potential for Runoff:	None
Comments:

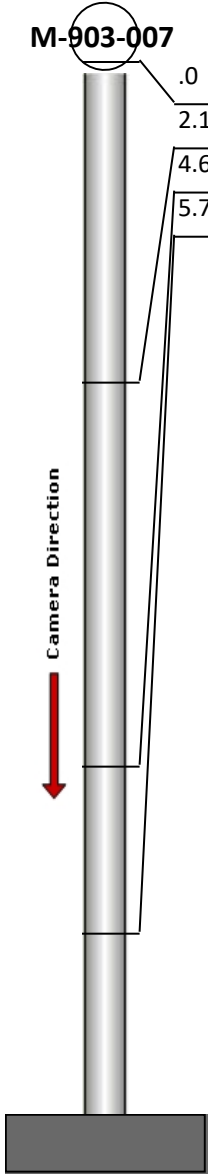
.0	MGP	General Photo	10	NA
	2.1	MGP	General Photo	28	NA
	4.6	DAZ	Deposits Attached Other	47	M 2
	5.7	MGO	General Observation	60	NA
