Manhole Inspection Report

Date:	03/20/2018	Weather:		Coding:	RZMACP
MH#:	M-903-009	Owner:	NA	Len. Surveyed:	4.6
P.O.#:		Surveyor:	John Kuglmaier	Rim to Invert:	5.6
Customer:		Cert. #:	U-1215-07002349	Wall Material:	Concrete (reinforced)

Street:	Spencer Pl. 43' South of 38th Pl.	Project:	Hobart, IN
City:	Hobart, IN	GPS Northing:	2911831.858
Location:		GPS Easting:	2911831.858
Drain Area:	Northeast	GPS Accuracy:	Sub-Meter
Cover Shape:	Circular	Evidence of Surcharge:	Yes
Cover Size:	23.0	Potential for Runoff:	None
Comments:

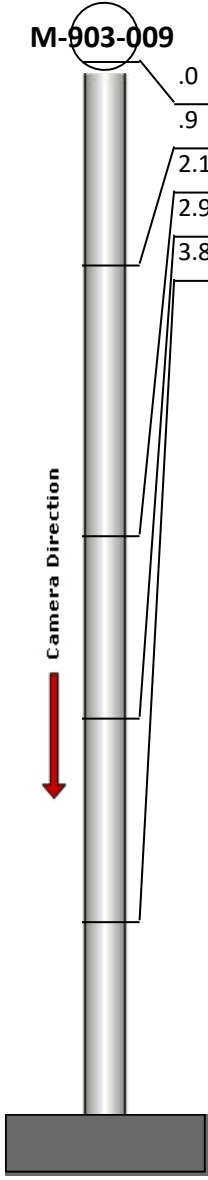
.0	MGP	General Photo	10	NA
	.9	IS	Infil Stain	24	NA
	2.1	MGP	General Photo	40	NA
	2.9	DAZ	Deposits Attached Other	56	M 2
	3.8	MGO	General Observation	69	NA
