Manhole Inspection Report

Date:	03/20/2018	Weather:		Coding:	RZMACP
MH#:	M-903-011	Owner:	NA	Len. Surveyed:	4.4
P.O.#:		Surveyor:	John Kuglmaier	Rim to Invert:	5.6
Customer:		Cert. #:	U-1215-07002349	Wall Material:	Concrete (reinforced)

Street:	Spencer Pl. 43' South of 38th Pl.	Project:	Hobart, IN
City:	Hobart, IN	GPS Northing:	2911563.667
Location:		GPS Easting:	2911563.667
Drain Area:	Northeast	GPS Accuracy:	Sub-Meter
Cover Shape:	Circular	Evidence of Surcharge:	Yes
Cover Size:	23.0	Potential for Runoff:	None
Comments:

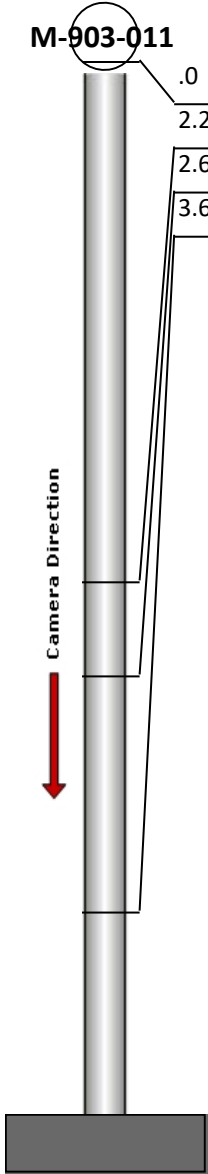
.0	MGP	General Photo	10	NA
	2.2	MGP	General Photo	28	NA
	2.6	DAZ	Deposits Attached Other	43	M 3
	3.6	MGO	General Observation	56	NA
