Manhole Inspection Report

Date:	03/28/2018	Weather:		Coding:	RZMACP
MH#:	M-903-026	Owner:	NA	Len. Surveyed:	8.9
P.O.#:		Surveyor:	John Kuglmaier	Rim to Invert:	10.4
Customer:		Cert. #:	U-1215-07002349	Wall Material:	Concrete (reinforced)

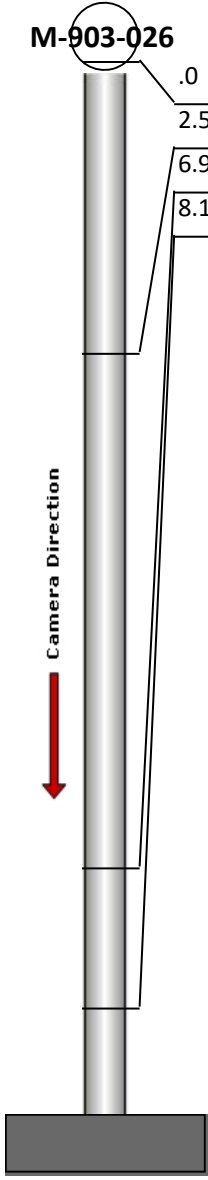
M-903-026				
	.0	MGP	General Photo	10	NA
	2.5	MGP	General Photo	29	NA
	6.9	DAZ	Deposits Attached Other	51	M 2
	8.1	MGO	General Observation	65	NA
