Manhole Inspection Report

Date:	04/12/2018	Weather:		Coding:	RZMACP
MH#:	M-903-033	Owner:	NA	Len. Surveyed:	10.0
P.O.#:		Surveyor:	John Kuglmaier	Rim to Invert:	11.6
Customer:		Cert. #:	U-1215-07002349	Wall Material:	Concrete (reinforced)

Street:	Wisconsin St. 29' North of 40th Plac	Project:	Hobart, IN
City:	Hobart, IN	GPS Northing:	2909717.473
Location:		GPS Easting:	2909717.473
Drain Area:	Northwest	GPS Accuracy:	Sub-Meter
Cover Shape:	Circular	Evidence of Surcharge:	Yes
Cover Size:	23.0	Potential for Runoff:	None
Comments:

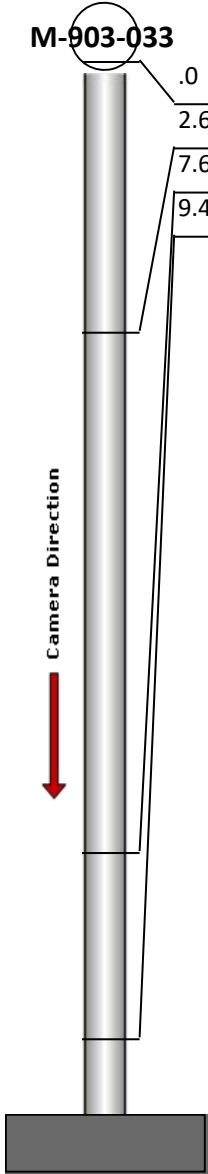
M-903-033				
	.0	MGP	General Photo	10	NA
	2.6	MGP	General Photo	29	NA
	7.6	DSF	Deposits Settled Fine	53	M 2
	9.4	MGO	General Observation	68	NA
