Manhole Inspection Report

Date:	03/20/2018	Weather:		Coding:	RZMACP
MH#:	M-903-041	Owner:	NA	Len. Surveyed:	5.3
P.O.#:		Surveyor:	John Kuglmaier	Rim to Invert:	6.4
Customer:		Cert. #:	U-1215-07002349	Wall Material:	Concrete (reinforced)

Street:	38th Pl. 696' East of Hwy 51.	Project:	Hobart, IN
City:	Hobart, IN	GPS Northing:	2910387.49
Location:		GPS Easting:	2910387.49
Drain Area:	Northeast	GPS Accuracy:	Sub-Meter
Cover Shape:	Circular	Evidence of Surcharge:	No
Cover Size:	23.0	Potential for Runoff:	None
Comments:

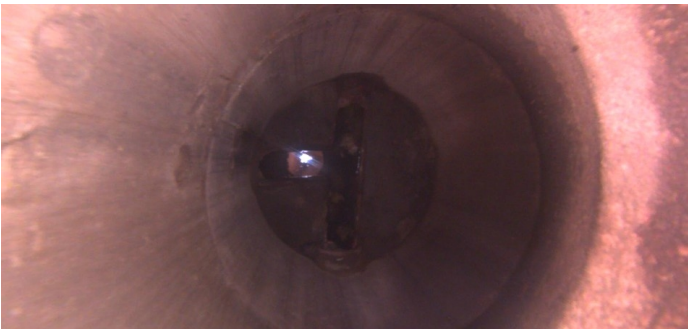
Code:

MGP

Description:

General Photo

Distance (ft):

.0

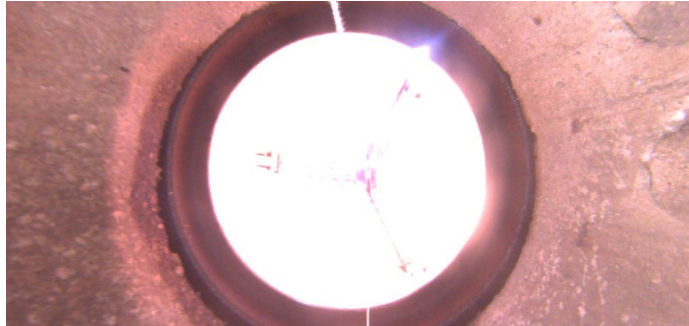
Code: **MGP**
Description: **General Photo**

Distance (ft): **2.1**
Structural Grade: **0**
O&M Grade: **0**
Clock Start/From:
Clock To:
1st Value:
2nd Value:
Value Percent:
Step: **NO**
Remarks:
