Manhole Inspection Report

Date:	03/20/2018	Weather:		Coding:	RZMACP
MH#:	M-903-042	Owner:	NA	Len. Surveyed:	4.6
P.O.#:		Surveyor:	John Kuglmaier	Rim to Invert:	5.8
Customer:		Cert. #:	U-1215-07002349	Wall Material:	Concrete (reinforced)

Street:	38th Pl. 547' West of Shelby Pl.	Project:	Hobart, IN
City:	Hobart, IN	GPS Northing:	2910661.237
Location:		GPS Easting:	2910661.237
Drain Area:	Northeast	GPS Accuracy:	Sub-Meter
Cover Shape:	Circular	Evidence of Surcharge:	No
Cover Size:	23.0	Potential for Runoff:	None
Comments:

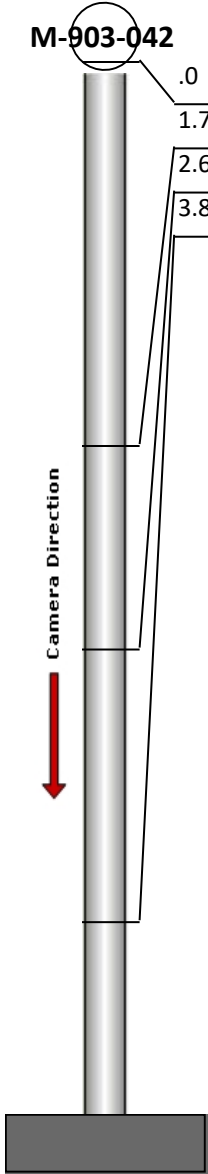
.0	MGP	General Photo	10	NA
	1.7	DSF	Deposits Settled Fine	25	M 2
	2.6	MGP	General Photo	40	NA
	3.8	MGO	General Observation	56	NA
