Manhole Inspection Report

Date:	04/12/2018	Weather:		Coding:	RZMACP
MH#:	M-903-050	Owner:	NA	Len. Surveyed:	5.7
P.O.#:		Surveyor:	John Kuglmaier	Rim to Invert:	6.9
Customer:		Cert. #:	U-1215-07002349	Wall Material:	Concrete (reinforced)

Street:	Wisconsin St. 29' North of 40th Plac	Project:	Hobart, IN
City:	Hobart, IN	GPS Northing:	2909709.253
Location:		GPS Easting:	2909709.253
Drain Area:	Northwest	GPS Accuracy:	Sub-Meter
Cover Shape:	Circular	Evidence of Surcharge:	Yes
Cover Size:	23.0	Potential for Runoff:	None
Comments:

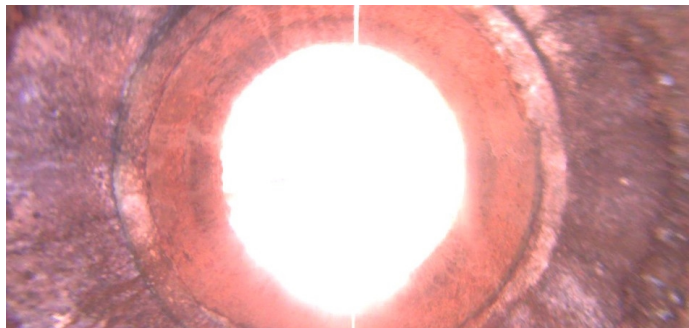
Code:	MGP
Description:	General Photo
Distance (ft):	2.2
Structural Grade:	0
O&M Grade:	0
Clock Start/From:	
Clock To:	
1st Value:	
2nd Value:	
Value Percent:	
Step:	NO
Remarks:

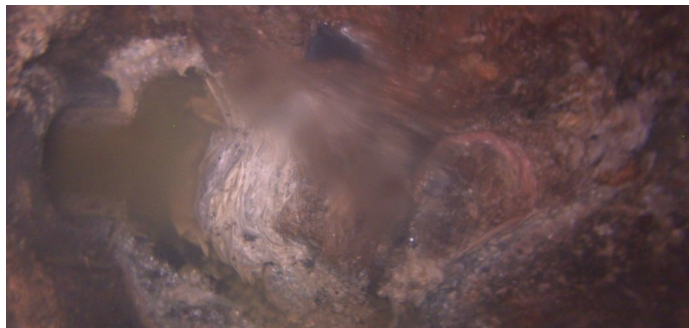
Code:	MGO
Description:	General Observation
Distance (ft):	4.7
Structural Grade:	0
O&M Grade:	0
Clock Start/From:	
Clock To:	
1st Value:	
2nd Value:	
Value Percent:	
Step:	NO
Remarks:	Ins. Comp.
