Manhole Inspection Report

Date:	03/21/2018	Weather:		Coding:	RZMACP
MH#:	M-903-053	Owner:	NA	Len. Surveyed:	4.0
P.O.#:		Surveyor:	John Kuglmaier	Rim to Invert:	5.4
Customer:		Cert. #:	U-1215-07002349	Wall Material:	Concrete (reinforced)

Street:	652' South of Hwy 6. 911' East of H	Project:	Hobart, IN
City:	Hobart, IN	GPS Northing:	0.0
Location:		GPS Easting:	0.0
Drain Area:	Northeast	GPS Accuracy:	Nearest Meter
Cover Shape:	Circular	Evidence of Surcharge:	No
Cover Size:	23.0	Potential for Runoff:	None
Comments:

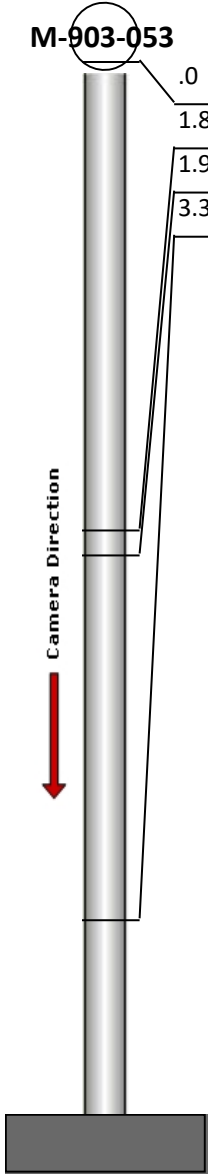
M-903-053				
	.0	MGP	General Photo	10	NA
	1.8	IS	Infil Stain	25	NA
	1.9	MGP	General Photo	39	NA
	3.3	MGO	General Observation	56	NA
