Manhole Inspection Report

Date:	03/21/2018	Weather:		Coding:	RZMACP
MH#:	M-903-055	Owner:	NA	Len. Surveyed:	5.3
P.O.#:		Surveyor:	John Kuglmaier	Rim to Invert:	6.4
Customer:		Cert. #:	U-1215-07002349	Wall Material:	Concrete (reinforced)

Street:	475' South of Hwy 6. 608' East of H	Project:	Hobart, IN
City:	Hobart, IN	GPS Northing:	0.0
Location:		GPS Easting:	0.0
Drain Area:	Northeast	GPS Accuracy:	Nearest Meter
Cover Shape:	Circular	Evidence of Surcharge:	Yes
Cover Size:	23.0	Potential for Runoff:	None
Comments:

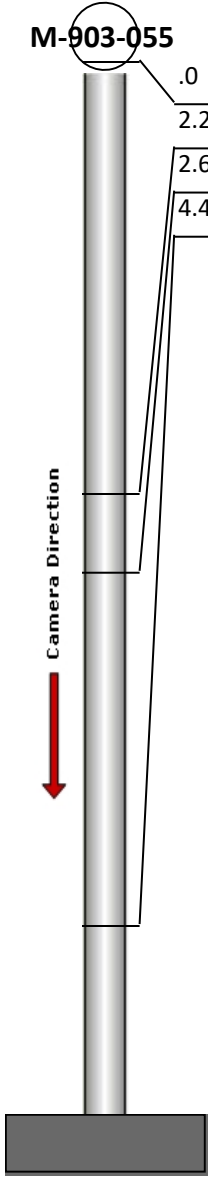
.0	MGP	General Photo	10	NA
	2.2	MGP	General Photo	28	NA
	2.6	DAZ	Deposits Attached Other	43	M 2
	4.4	MGO	General Observation	58	NA
