Manhole Inspection Report

Date:	03/20/2018	Weather:		Coding:	RZMACP
MH#:	M-903-065	Owner:	NA	Len. Surveyed:	2.2
P.O.#:		Surveyor:	John Kuglmaier	Rim to Invert:	3.0
Customer:		Cert. #:	U-1215-07002349	Wall Material:	Concrete (reinforced)

Street:	198' West of Union St. 388' South of	Project:	Hobart, IN
City:	Hobart, IN	GPS Northing:	2912127.421
Location:		GPS Easting:	2912127.421
Drain Area:	Northeast	GPS Accuracy:	Sub-Meter
Cover Shape:	Circular	Evidence of Surcharge:	Yes
Cover Size:	23.0	Potential for Runoff:	None
Comments:

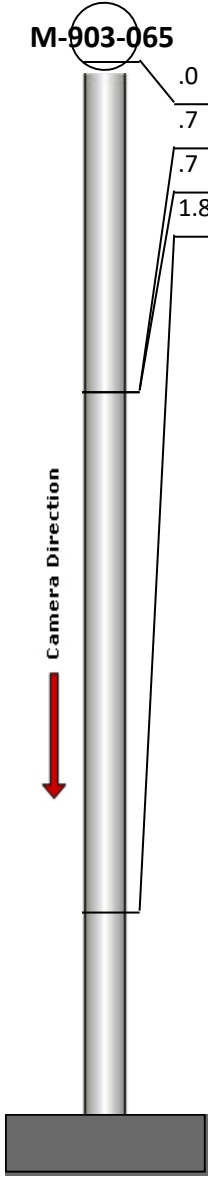
M-903-065				
	.0	MGP	General Photo	10	NA
	.7	MGO	General Observation	23	NA
	.7	DAZ	Deposits Attached Other	34	M 4
	1.8	MGO	General Observation	48	NA
