# Manhole Inspection Report

| MH#: | M-904-001 | Owner: | NA | Len. Surveyed: | 7.9 |

| Street: | Union St. 484' South of Home Ave. | Project: | Hobart, IN |

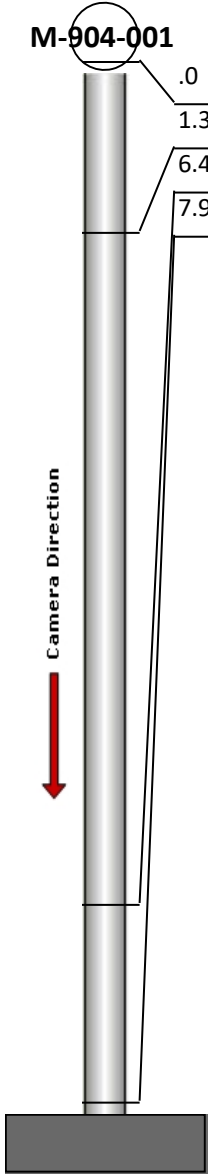
| | Position | Code | Observation | Video (sec) | Grade |
|--|---|---|---|---|---|
| | .0 | MGP | General Photo | 10 | NA |
| | 1.3 | MGO | General Observation | 26 | NA |
| | 6.4 | DSF | Deposits Settled Fine | 49 | M 2 |
| | 7.9 | MGO | General Observation | 64 | NA |
