Manhole Inspection Report

Date:	05/11/2018	Weather:		Coding:	RZMACP
MH#:	M-904-012	Owner:	NA	Len. Surveyed:	13.4
P.O.#:		Surveyor:	Jen Costello	Rim to Invert:	15.0
Customer:		Cert. #:	U-907-5518	Wall Material:	Concrete (reinforced)

Street:	Fraser Ln. to the Northwest.	Project:	Hobart, IN
City:	Hobart, IN	GPS Northing:	2911289.039
Location:		GPS Easting:	2911289.039
Drain Area:	Northeast	GPS Accuracy:	Sub-Meter
Cover Shape:	Circular	Evidence of Surcharge:	No
Cover Size:	22.5	Potential for Runoff:	None
Comments:

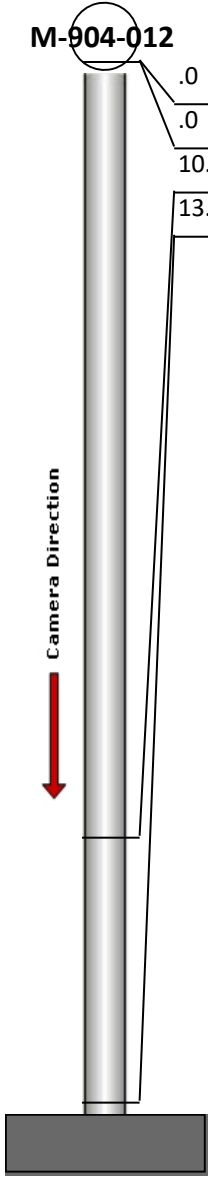
.0	MGO	General Observation	10	NA
	.0	FM	Fracture Multiple	20	S 4
	10.0	IW	Infil Weeper	51	M 2
	13.4	MGO	General Observation	69	NA
