# Manhole Inspection Report

Date:	05/08/2018	Weather:		Coding:	RZMACP
MH#:	M-904-021	Owner:	NA	Len. Surveyed:	5.6
P.O.#:		Surveyor:	Jen Costello	Rim to Invert:	6.2
Customer:		Cert. #:	U-907-5518	Wall Material:	Concrete (reinforced)

Street:	Fraser St. West. 181' North of Clevel	Project:	Hobart, IN
City:	Hobart, IN	GPS Northing:	2911283.613
Location:		GPS Easting:	2911283.613
Drain Area:	Northeast	GPS Accuracy:	Sub-Meter
Cover Shape:	Circular	Evidence of Surcharge:	No
Cover Size:	22.5	Potential for Runoff:	None
Comments:

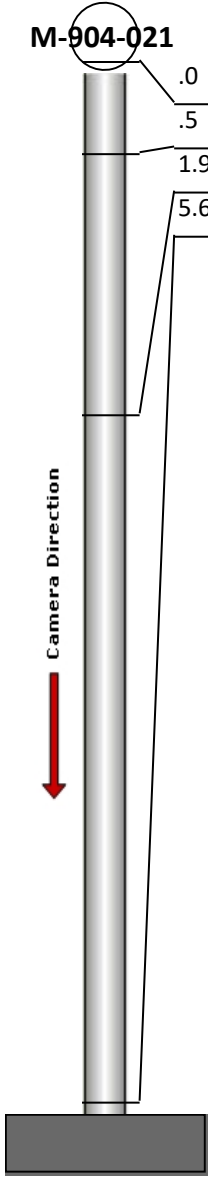
.0	MGP	General Photo	10	NA
	.5	SAV	Surface Aggregate Visible	22	S 3
	1.9	MGO	General Observation	39	NA
	5.6	MGO	General Observation	60	NA
