# Manhole Inspection Report

Date:	05/09/2018	Weather:		Coding:	RZMACP
MH#:	M-904-024	Owner:	NA	Len. Surveyed:	3.1
P.O.#:		Surveyor:	Jen Costello	Rim to Invert:	2.9
Customer:		Cert. #:	U-907-5518	Wall Material:	Concrete (reinforced)

Street:	Cleveland Ave. 198' East of Clevelan	Project:	Hobart, IN
City:	Hobart, IN	GPS Northing:	41.53136063
Location:		GPS Easting:	-87.2362442
Drain Area:	Northeast	GPS Accuracy:	Nearest Meter
Cover Shape:	Circular	Evidence of Surcharge:	No
Cover Size:	22.5	Potential for Runoff:	None
Comments:

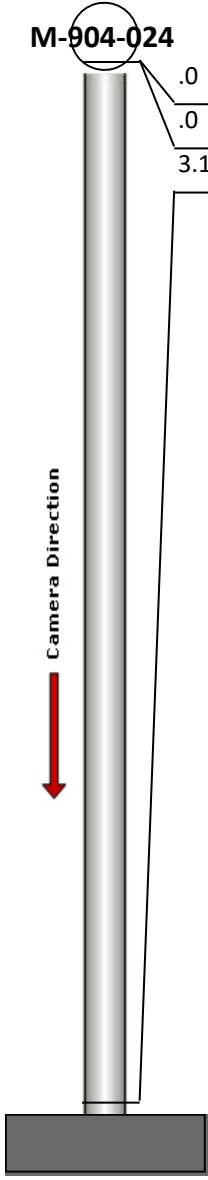
M-904-024				
	.0	MGO	General Observation	10	NA
	.0	SAV	Surface Aggregate Visible	22	S 3
	3.1	MGO	General Observation	39	NA
