Manhole Inspection Report

Date:	05/07/2018	Weather:		Coding:	RZMACP
MH#:	M-904-032	Owner:	NA	Len. Surveyed:	7.0
P.O.#:		Surveyor:	Jen Costello	Rim to Invert:	7.2
Customer:		Cert. #:	U-907-5518	Wall Material:	Concrete (reinforced)

Street:	East Cleveland Terrace. 320' North o	Project:	Hobart, IN
City:	Hobart, IN	GPS Northing:	2910915.165
Location:		GPS Easting:	2910915.165
Drain Area:	Northeast	GPS Accuracy:	Sub-Meter
Cover Shape:	Circular	Evidence of Surcharge:	No
Cover Size:	22.5	Potential for Runoff:	None
Comments:

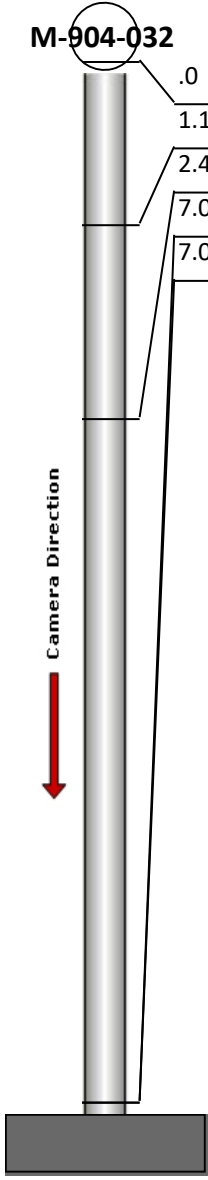
.0	MGO	General Observation	10	NA
	1.1	MGO	General Observation	25	NA
	2.4	SAV	Surface Aggregate Visible	41	S 3
	7.0	DSF	Deposits Settled Fine	62	M 2
	7.0	MGO	General Observation	73	NA
