Manhole Inspection Report

Date:	05/07/2018	Weather:		Coding:	RZMACP
MH#:	M-904-033	Owner:	NA	Len. Surveyed:	6.3
P.O.#:		Surveyor:	Jen Costello	Rim to Invert:	6.8
Customer:		Cert. #:	U-907-5518	Wall Material:	Concrete (reinforced)

Street:	E. Cleveland Terrace. 578' North of C	Project:	Hobart, IN
City:	Hobart, IN	GPS Northing:	2910906.524
Location:		GPS Easting:	2910906.524
Drain Area:	Northeast	GPS Accuracy:	Sub-Meter
Cover Shape:	Circular	Evidence of Surcharge:	No
Cover Size:	22.5	Potential for Runoff:	None
Comments:

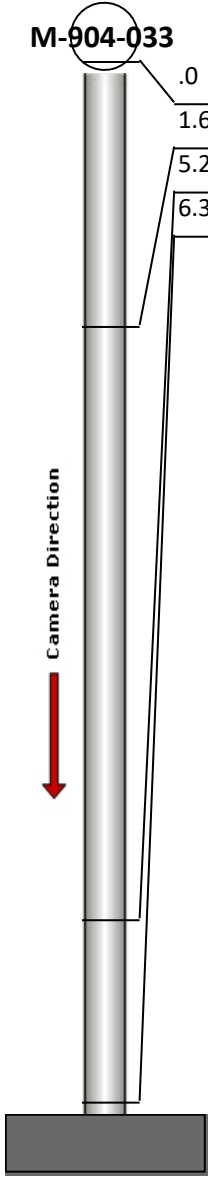
Position	Code	Observation	Video (sec)	Grade

.0	MGP	General Photo	10	NA
	1.6	MGO	General Observation	26	NA
	5.2	DSF	Deposits Settled Fine	46	M 2
	6.3	MGO	General Observation	60	NA
