Manhole Inspection Report

Date:	05/08/2018	Weather:		Coding:	RZMACP
MH#:	M-904-064	Owner:	NA	Len. Surveyed:	6.5
P.O.#:		Surveyor:	Jen Costello	Rim to Invert:	6.9
Customer:		Cert. #:	U-907-5518	Wall Material:	Concrete (reinforced)

Street:	Intersection of Home Ave. and Pem	Project:	Hobart, IN
City:	Hobart, IN	GPS Northing:	2912180.768
Location:		GPS Easting:	2912180.768
Drain Area:	Northeast	GPS Accuracy:	Sub-Meter
Cover Shape:	Circular	Evidence of Surcharge:	No
Cover Size:	22.5	Potential for Runoff:	None
Comments:

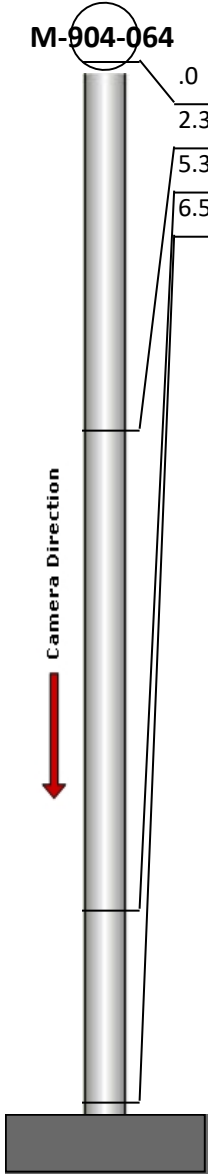
.0	MGP	General Photo	10	NA
	2.3	MGO	General Observation	28	NA
	5.3	DSF	Deposits Settled Fine	48	M 2
	6.5	MGO	General Observation	62	NA
