Manhole Inspection Report

Date:	05/11/2018	Weather:		Coding:	RZMACP
MH#:	M-904-068	Owner:	NA	Len. Surveyed:	8.0
P.O.#:		Surveyor:	Jen Costello	Rim to Invert:	8.7
Customer:		Cert. #:	U-907-5518	Wall Material:	Concrete (reinforced)

Street:	Pembroke Dr. West. 309' South of P	Project:	Hobart, IN
City:	Hobart, IN	GPS Northing:	2911861.283
Location:		GPS Easting:	2911861.283
Drain Area:	Northeast	GPS Accuracy:	Sub-Meter
Cover Shape:	Circular	Evidence of Surcharge:	No
Cover Size:	22.5	Potential for Runoff:	None
Comments:

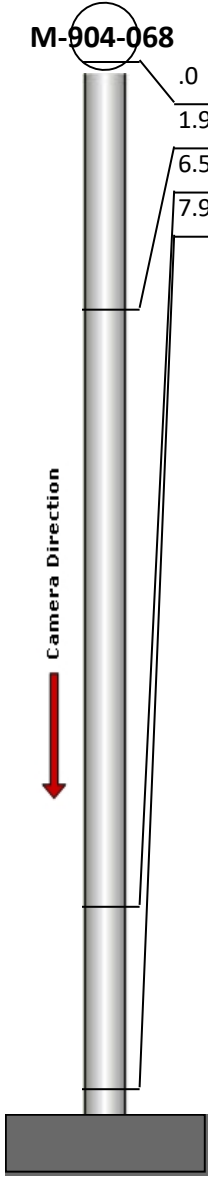
.0	MGO	General Observation	10	NA
	1.9	MGO	General Observation	27	NA
	6.5	DSF	Deposits Settled Fine	50	M 2
	7.9	MGO	General Observation	64	NA
