# Manhole Inspection Report

Date:	05/09/2018	Weather:		Coding:	RZMACP
MH#:	M-905-030	Owner:	NA	Len. Surveyed:	3.5
P.O.#:		Surveyor:	Jen Costello	Rim to Invert:	3.6
Customer:		Cert. #:	U-907-5518	Wall Material:	Concrete (reinforced)

Street:	132' West of Shelby St. 687' North of	Project:	Hobart, IN
City:	Hobart, IN	GPS Northing:	2910957.76
Location:		GPS Easting:	2910957.76
Drain Area:	Southeast	GPS Accuracy:	Sub-Meter
Cover Shape:	Circular	Evidence of Surcharge:	No
Cover Size:	22.5	Potential for Runoff:	None
Comments:

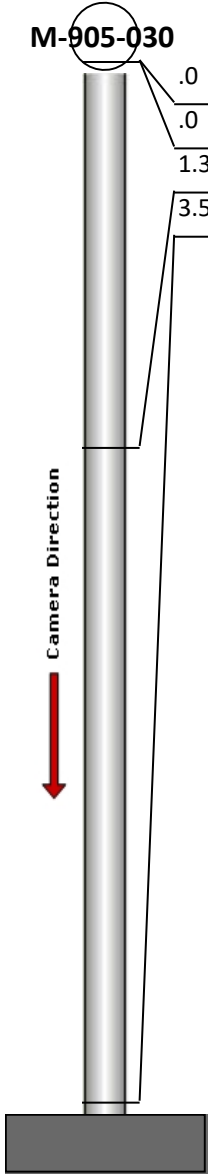
.0	MGP	General Photo	10	NA
	.0	IW	Infil Weeper	22	M 2
	1.3	MGO	General Observation	37	NA
	3.5	MGO	General Observation	55	NA
