Manhole Inspection Report

Date:	05/09/2018	Weather:		Coding:	RZMACP
MH#:	M-905-036	Owner:	NA	Len. Surveyed:	3.0
P.O.#:		Surveyor:	Jen Costello	Rim to Invert:	3.0
Customer:		Cert. #:	U-907-5518	Wall Material:	Concrete (reinforced)

Street:	232' North of Hwy 130. 193' West o	Project:	Hobart, IN
City:	Hobart, IN	GPS Northing:	2910892.986
Location:		GPS Easting:	2910892.986
Drain Area:	Southeast	GPS Accuracy:	Sub-Meter
Cover Shape:	Circular	Evidence of Surcharge:	No
Cover Size:	18.0	Potential for Runoff:	None
Comments:

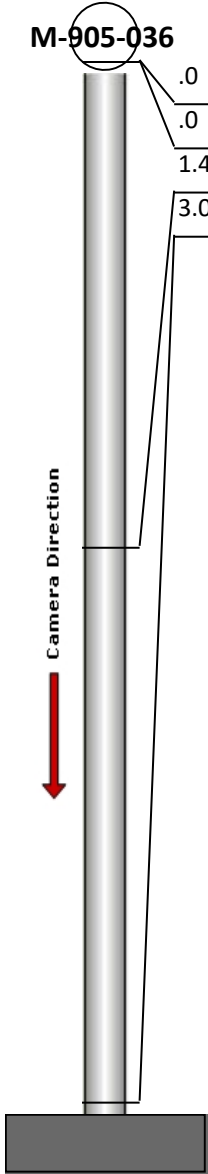
.0	MGP	General Photo	10	NA
	.0	DAE	Deposits Attached Encrustation	21	M 2
	1.4	MGP	General Photo	37	NA
	3.0	MSA	Abandoned Survey	54	NA
