Manhole Inspection Report

Date:	04/22/2018	Weather:		Coding:	RZMACP
MH#:	M-906-002	Owner:	NA	Len. Surveyed:	9.1
P.O.#:		Surveyor:	John Kuglmaier	Rim to Invert:	9.5
Customer:	8.7	Cert. #:	U-1215-07002349	Wall Material:	Concrete (reinforced)

Street:	10th St. 208' West of Sullivan Dr.	Project:	Hobart, IN
City:	Hobart, IN	GPS Northing:	0.0
Location:		GPS Easting:	0.0
Drain Area:	Southeast	GPS Accuracy:	Nearest Meter
Cover Shape:	Circular	Evidence of Surcharge:	Yes
Cover Size:	22.5	Potential for Runoff:	None
Comments:

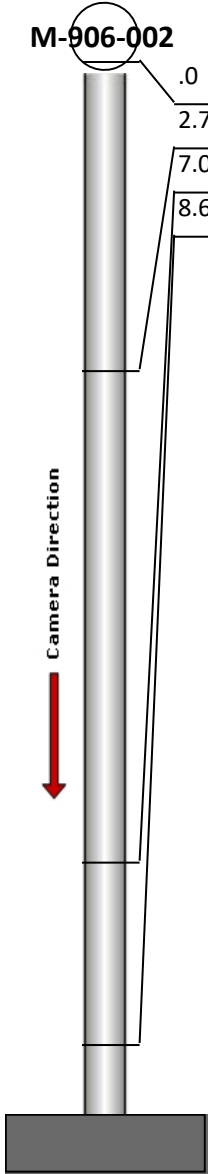
M-906-002				
	.0	MGP	General Photo	10	NA
	2.7	MGP	General Photo	29	NA
	7.0	DAZ	Deposits Attached Other	52	M 3
	8.6	MGO	General Observation	66	NA
