Manhole Inspection Report

Date:	04/22/2018	Weather:		Coding:	RZMACP
MH#:	M-906-005	Owner:	NA	Len. Surveyed:	6.4
P.O.#:		Surveyor:	John Kuglmaier	Rim to Invert:	6.3
Customer:	8.7	Cert. #:	U-1215-07002349	Wall Material:	Concrete (reinforced)

Street:	9th Pl. 342' West of Sullivan Dr.	Project:	Hobart, IN
City:	Hobart, IN	GPS Northing:	0.0
Location:		GPS Easting:	0.0
Drain Area:	Southeast	GPS Accuracy:	Nearest Meter
Cover Shape:	Circular	Evidence of Surcharge:	No
Cover Size:	22.5	Potential for Runoff:	None
Comments:

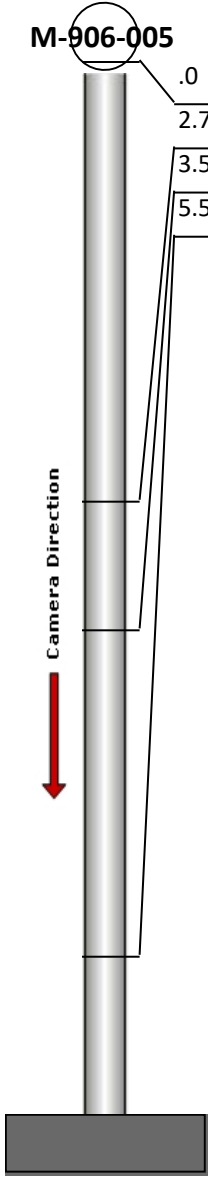
.0	MGP	General Photo	10	NA
	2.7	MGP	General Photo	29	NA
	3.5	DAZ	Deposits Attached Other	44	M 2
	5.5	MGO	General Observation	60	NA
