Manhole Inspection Report

Date:	04/22/2018	Weather:		Coding:	RZMACP
MH#:	M-906-006	Owner:	NA	Len. Surveyed:	7.5
P.O.#:		Surveyor:	John Kuglmaier	Rim to Invert:	7.5
Customer:	8.7	Cert. #:	U-1215-07002349	Wall Material:	Concrete (reinforced)

Street:	Intersection of Duck Cr. Ct. and 9th	Project:	Hobart, IN
City:	Hobart, IN	GPS Northing:	0.0
Location:		GPS Easting:	0.0
Drain Area:	Southeast	GPS Accuracy:	Nearest Meter
Cover Shape:	Circular	Evidence of Surcharge:	No
Cover Size:	22.5	Potential for Runoff:	None
Comments:

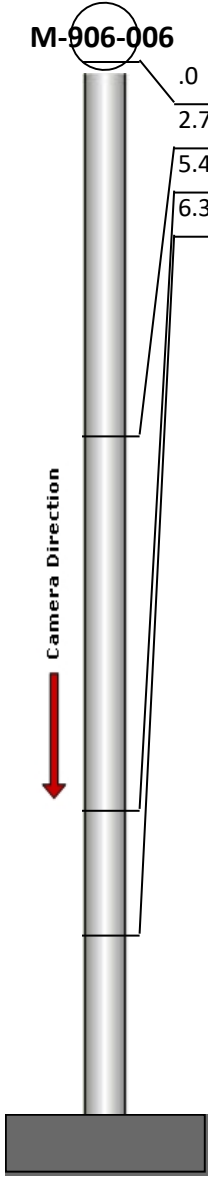
.0	MGP	General Photo	10	NA
	2.7	MGP	General Photo	29	NA
	5.4	DAZ	Deposits Attached Other	48	M 2
	6.3	MGO	General Observation	62	NA
