Manhole Inspection Report

Date:	04/22/2018	Weather:		Coding:	RZMACP
MH#:	M-906-013	Owner:	NA	Len. Surveyed:	6.3
P.O.#:		Surveyor:	John Kuglmaier	Rim to Invert:	6.5
Customer:	8.7	Cert. #:	U-1215-07002349	Wall Material:	Concrete (reinforced)

Street:	10th St. 707' West of Duck Cr. Ct.	Project:	Hobart, IN
City:	Hobart, IN	GPS Northing:	0.0
Location:		GPS Easting:	0.0
Drain Area:	Southeast	GPS Accuracy:	Nearest Meter
Cover Shape:	Circular	Evidence of Surcharge:	Yes
Cover Size:	22.5	Potential for Runoff:	None
Comments:

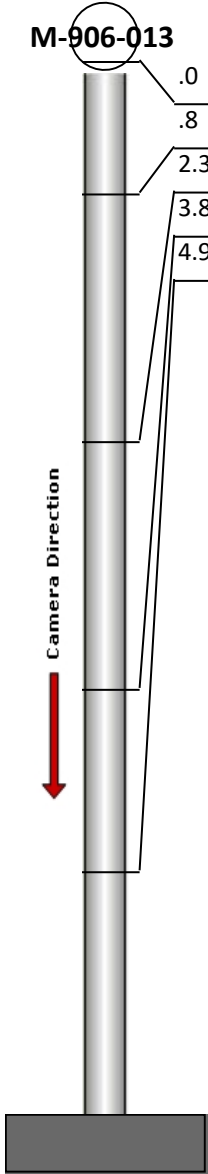
.0	MGP	General Photo	10	NA
	.8	IS	Infil Stain	23	NA
	2.3	MGP	General Photo	40	NA
	3.8	DAZ	Deposits Attached Other	57	M 3
	4.9	MGO	General Observation	71	NA
