# Manhole Inspection Report

Date:	04/22/2018	Weather:		Coding:	RZMACP
MH#:	M-907-004	Owner:	NA	Len. Surveyed:	10.5
P.O.#:		Surveyor:	Jen Costello	Rim to Invert:	11.9
Customer:	8.7	Cert. #:	U-907-5518	Wall Material:	Concrete (reinforced)

Street:	On Hobart Rd. 484' South of 10th St.	Project:	Hobart, IN
City:	Hobart, IN	GPS Northing:	0.0
Location:		GPS Easting:	0.0
Drain Area:	Southeast	GPS Accuracy:	Nearest Meter
Cover Shape:	Circular	Evidence of Surcharge:	No
Cover Size:	22.5	Potential for Runoff:	None
Comments:

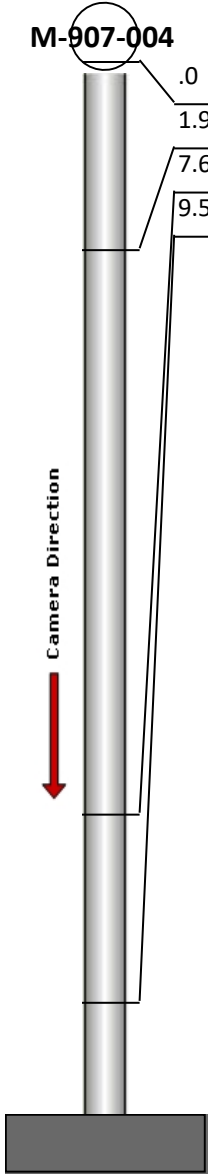
0.0	MGO	General Observation	10	NA
	1.9	MGP	General Photo	28	NA
	7.6	IS	Infil Stain	53	NA
	9.5	DSF	Deposits Settled Fine	68	M 2
