Manhole Inspection Report

Date:	04/19/2018	Weather:		Coding:	RZMACP
MH#:	M-907-007	Owner:	NA	Len. Surveyed:	10.9
P.O.#:		Surveyor:	Jen Costello	Rim to Invert:	11.7
Customer:		Cert. #:	U-907-5518	Wall Material:	Concrete (reinforced)

Street:	On Hobart Rd. 1711' South of 10th S	Project:	Hobart, IN
City:	Hobart, IN	GPS Northing:	2909981.81
Location:		GPS Easting:	2909981.81
Drain Area:	Southeast	GPS Accuracy:	Sub-Meter
Cover Shape:	Circular	Evidence of Surcharge:	No
Cover Size:	22.5	Potential for Runoff:	None
Comments:

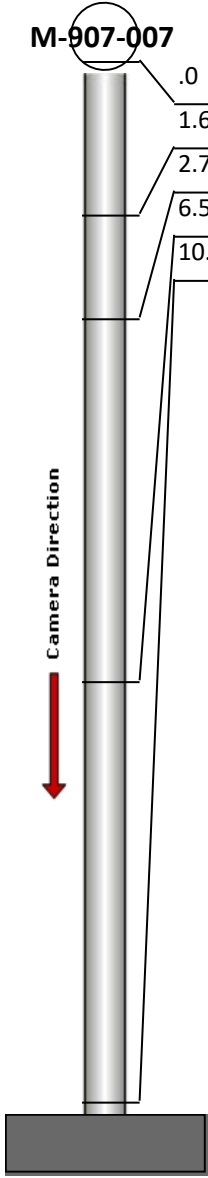
.0	MGO	General Observation	10	NA
	1.6	MGO	General Observation	26	NA
	2.7	IS	Infil Stain	41	NA
	6.5	OBP	Obstacle External Pipe or Cable	59	M 4
	10.9	MGO	General Observation	79	NA
