Manhole Inspection Report

Date:	04/22/2018	Weather:		Coding:	RZMACP
MH#:	M-907-009A	Owner:	NA	Len. Surveyed:	14.8
P.O.#:		Surveyor:	Jen Costello	Rim to Invert:	14.7
Customer:	8.7	Cert. #:	U-907-5518	Wall Material:	Concrete (reinforced)

Street:	10th St. and Union St. Hobart High S	Project:	Hobart, IN
City:	Hobart, IN	GPS Northing:	0.0
Location:		GPS Easting:	0.0
Drain Area:	Southeast	GPS Accuracy:	Nearest Meter
Cover Shape:	Circular	Evidence of Surcharge:	No
Cover Size:	22.5	Potential for Runoff:	None
Comments:

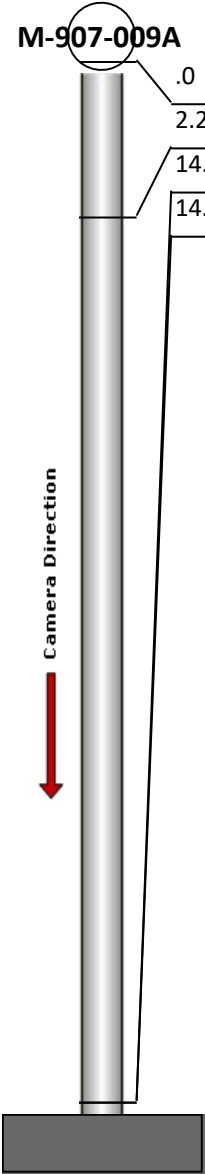
Position	Code	Observation	Video (sec)	Grade
M-907-009A

.0	MGO	General Observation	10	NA
	2.2	MGO	General Observation	28	NA
	14.8	MGO	General Observation	66	NA
	14.8	DSF	Deposits Settled Fine	78	M 2
