Manhole Inspection Report

Date:	04/22/2018	Weather:		Coding:	RZMACP
MH#:	M-907-019	Owner:	NA	Len. Surveyed:	11.5
P.O.#:		Surveyor:	Jen Costello	Rim to Invert:	12.2
Customer:	8.7	Cert. #:	U-907-5518	Wall Material:	Concrete (reinforced)

Street:	10th St. and Union St. Hobart High S	Project:	Hobart, IN
City:	Hobart, IN	GPS Northing:	0.0
Location:		GPS Easting:	0.0
Drain Area:	Southeast	GPS Accuracy:	Nearest Meter
Cover Shape:	Circular	Evidence of Surcharge:	No
Cover Size:	22.5	Potential for Runoff:	None
Comments:

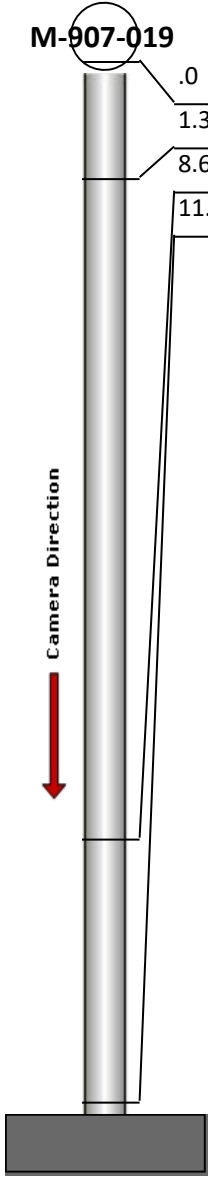
.0	MGO	General Observation	10	NA
	1.3	MGP	General Photo	26	NA
	8.6	IS	Infil Stain	53	NA
	11.5	MGO	General Observation	70	NA
