Manhole Inspection Report

Date:	04/22/2018	Weather:		Coding:	RZMACP
MH#:	M-907-021	Owner:	NA	Len. Surveyed:	18.2
P.O.#:		Surveyor:	Jen Costello	Rim to Invert:	18.1
Customer:	8.7	Cert. #:	U-907-5518	Wall Material:	Concrete (reinforced)

Street:	10th St. and Union St. Hobart High S	Project:	Hobart, IN
City:	Hobart, IN	GPS Northing:	0.0
Location:		GPS Easting:	0.0
Drain Area:	Southeast	GPS Accuracy:	Nearest Meter
Cover Shape:	Circular	Evidence of Surcharge:	No
Cover Size:	22.5	Potential for Runoff:	None
Comments:

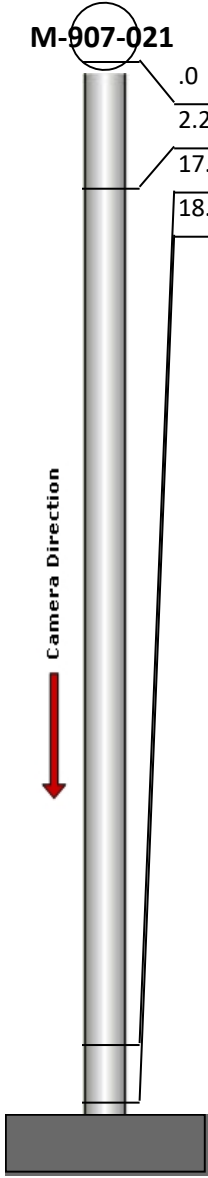
M-907-021				
	.0	MGO	General Observation	10	NA
	2.2	MGP	General Photo	28	NA
	17.2	DSZ	Deposits Settled Other	72	M 2
	18.2	MGO	General Observation	85	NA
